EVALUATION REPORT

RUM RIVER DAM

CITY OF ANOKA, MINNESOTA

October 1996

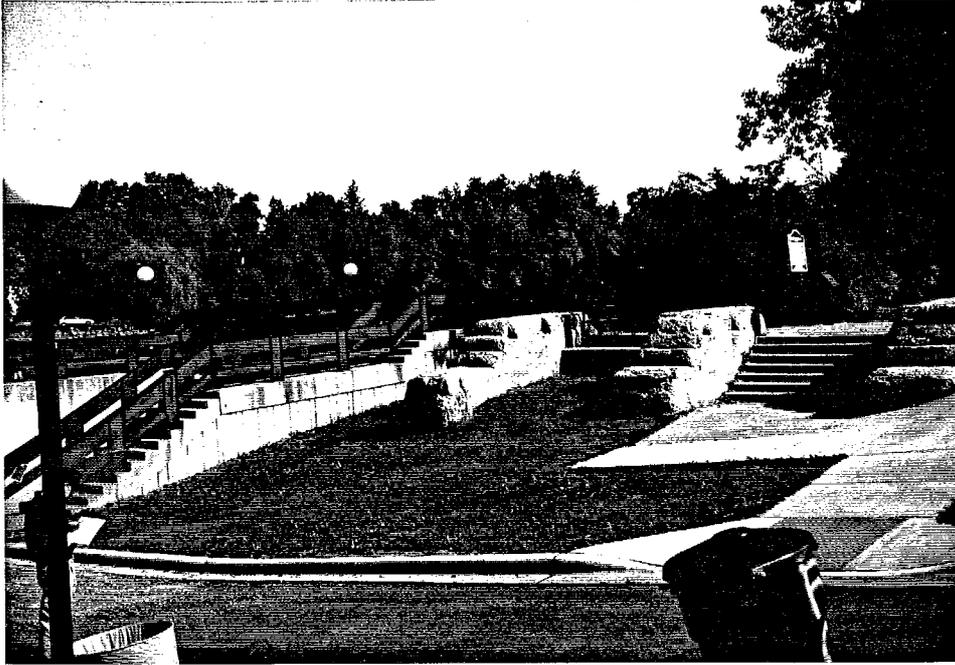
Photograph 4. Downstream view of left abutment area.

The majority of these recommended repairs can be completed by City personnel. It is however recommended that the new tainter gate paint system be completed by an experienced contractor. In addition, the City may wish to consider repairing the surface concrete of the former powerhouse piers located in the left abutment area. Consideration should be given to the historic value of the piers before proceeding with repairs. Reference Photograph 4.

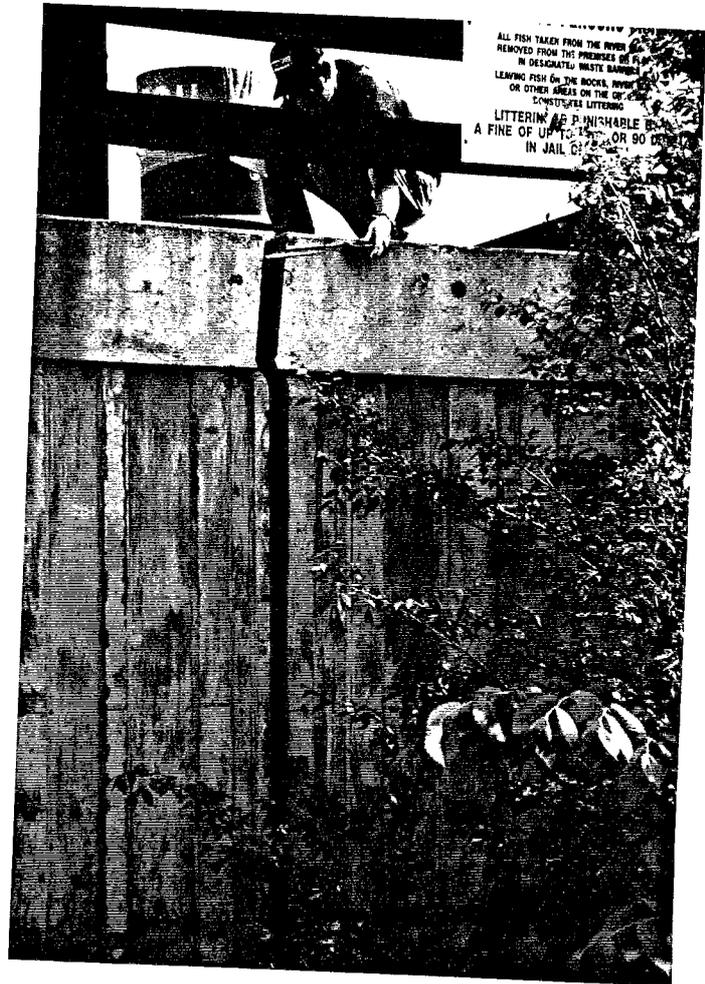
Handrail at downstream edge of the overlook and on the abutment wall near upstream edge of overlook is loose. In addition and as shown on Photographs 8 and 9, the joint in the abutment wall at downstream edge of overlook area has opened about 2.75 inches at the top of the wall. Evidence of the separation is also depicted in Photograph 10. This movement was reported in 1987 [1] and should continue to be monitored as part of future observations.

Photograph 8. Joint separation at right overlook structure.

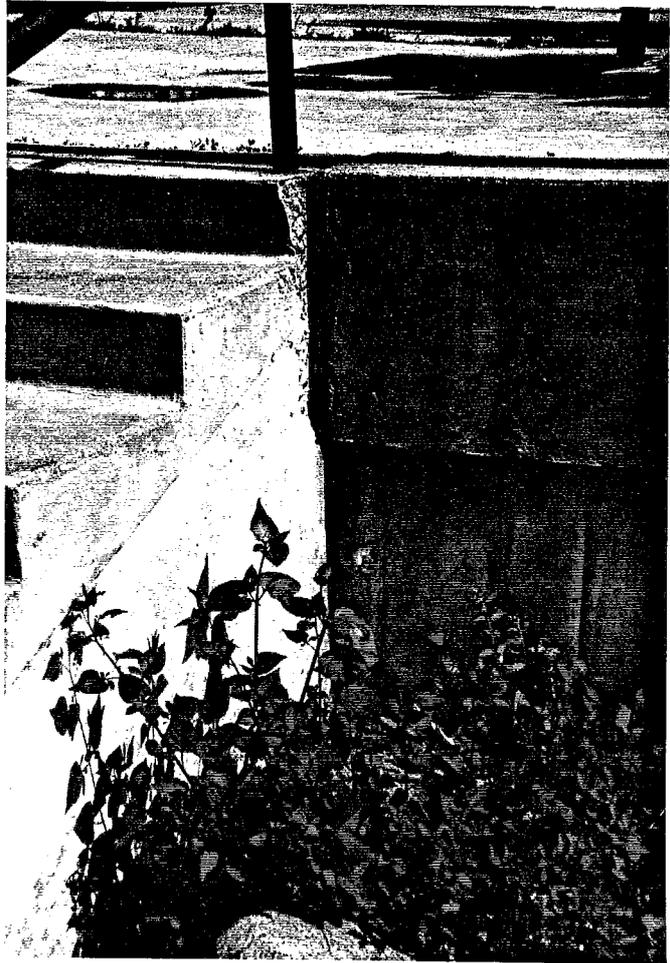
Photograph 10. Downstream end of overlook.
Note separation at joint.

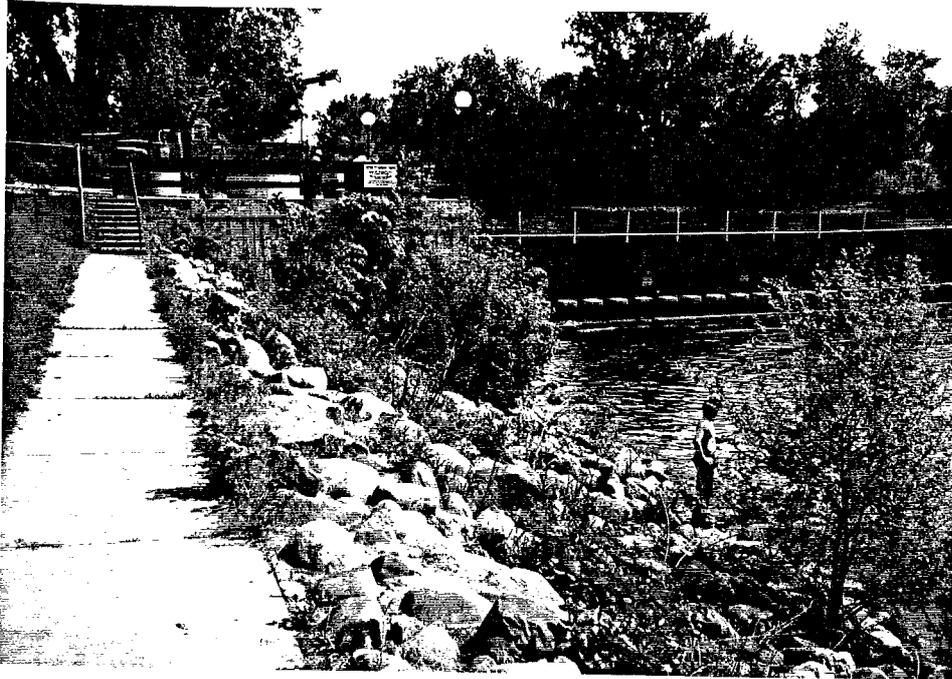
- The riprap system is in fair condition with some loss of material having taken place through the years. The riprap itself is less desirable than that of the left bank because of its rounded (rather than angular) shape.
- As was the case with the left bank, 30 to 40 small trees are present and should be removed.
- A 12-inch diameter concrete drain pipe located a short distance downstream of the overlook was dry.
- A concrete/rock apron, located just downstream of the overlook, is being undermined and should be repaired.

Photograph 12. Downstream right bank.

- j. The seep observed on the left bank, should continue to be monitored. Reference Photograph 15.
- k. The right downstream revetment should continue to be monitored for loss of riprap protection. Reference Photograph 12.

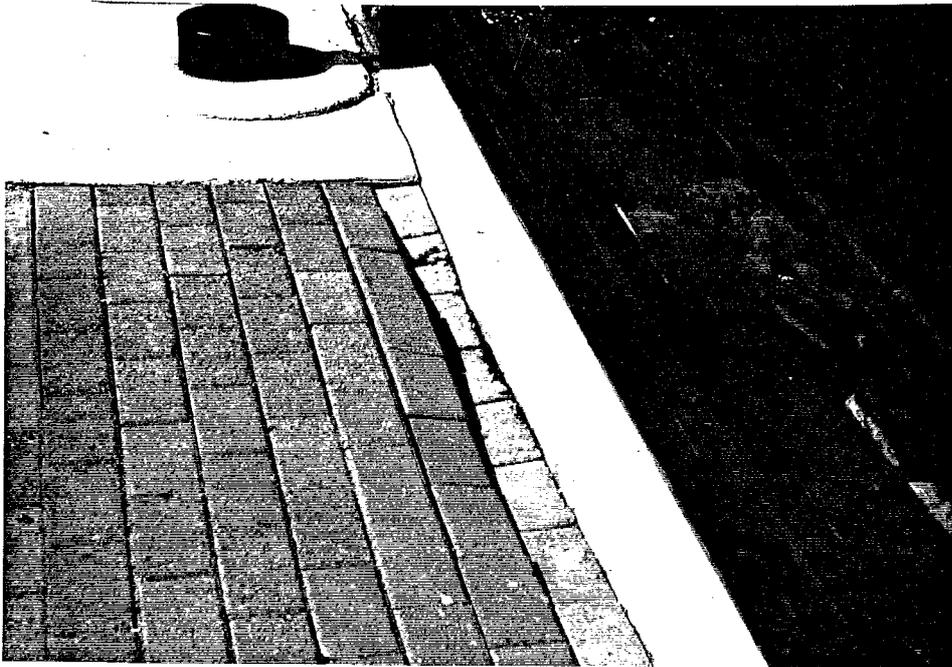
- Approximately 30 to 40 small (<3" diameter) trees are present on the bank and should be removed.
- Some settlement of the walkway was observed at three locations (reference Photograph 14). This settlement should be monitored and repaired if and when walking safety becomes an issue.
- A 6-inch diameter drain located 30-feet downstream of the tainter gate structure was flowing about 1/3 full, with clear water. This is not a concern, but included for comparison during the next field observation.
- A small seep was observed on the bank, approximately 170 feet downstream of the tainter gate structure (reference Photograph 15). No sand or fines were observed in the seep. Monitoring of this seep should continue.

Photograph 14. Typical settlement on downstream left walkway.

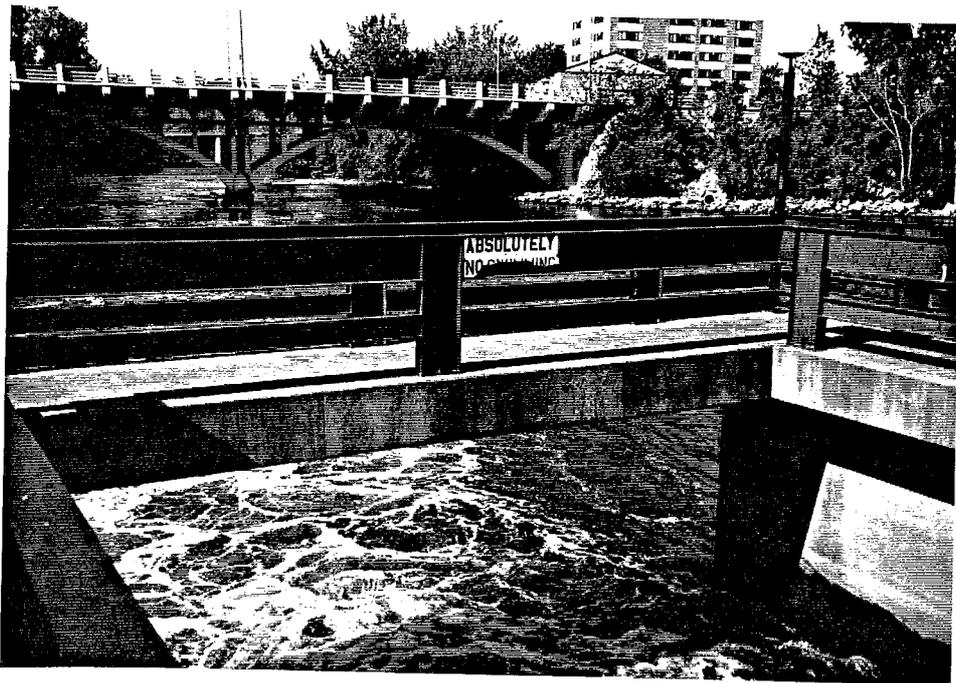
Some of the signage located on the tainter gate structure is aged and becoming difficult to read (reference Photograph 21). These signs should be replaced.

Photograph 21. Pedestrian walkway.

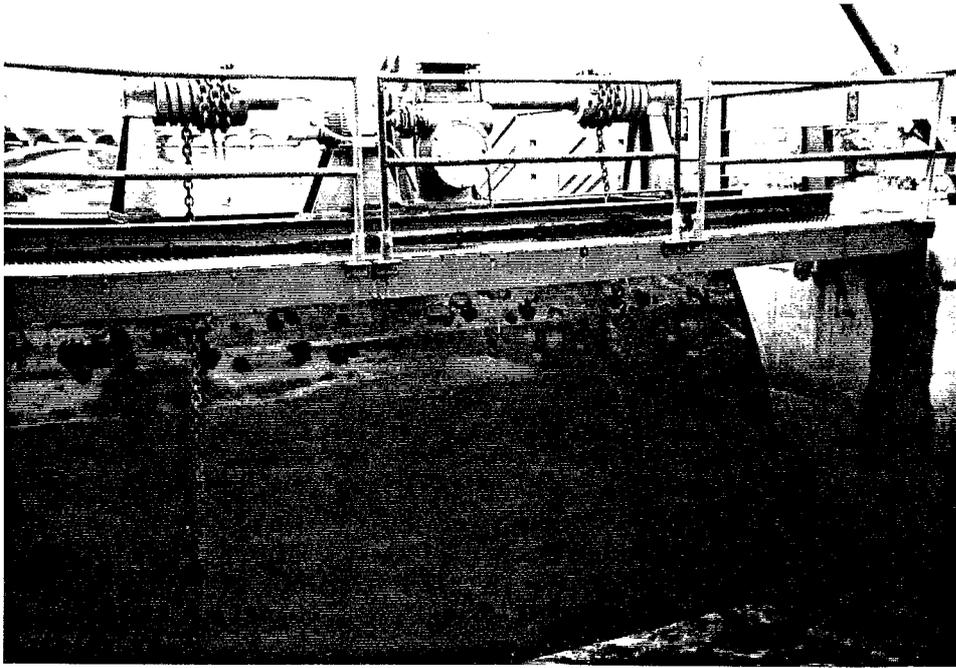
Photographs 22 and 23 show the tainter gate and hoist system. The tainter gate itself appears to be in good condition, except for its paint system and apparent slight misalignment. The paint is peeling near the top of the gate panel on the upstream side and on most of the downstream side of the gate. The tainter gate hoist support beams appear to be in good condition, but the paint is peeling allowing the steel to rust. The gate's apparent misalignment is observable from the leakage along the left and bottom seals (reference Photograph 24). Misalignment could be due to either lifting chain dissimilarity or shifting of the gate/structure itself. It is recommended that the gate lifting chains be adjusted to provide level closure of the gate against the sill's base plate. The tainter gate is fully functional as evidenced by its operation during the underwater inspection.

Photograph 22. Upstream view of tainter gate and hoist system.

- f. A new paint system should be applied to the tainter gate. Reference Photograph 22.
- g. Repair the surface concrete of the floodwall in the left abutment area. Reference Photograph 5.

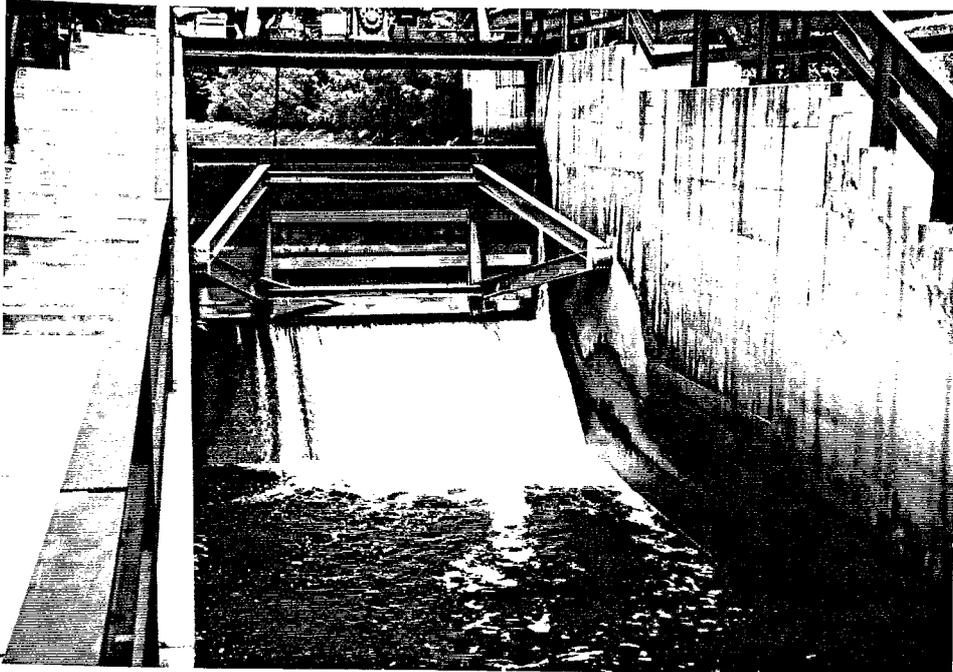
Photograph 24. Downstream view of closed tainter gate. Note leakage.

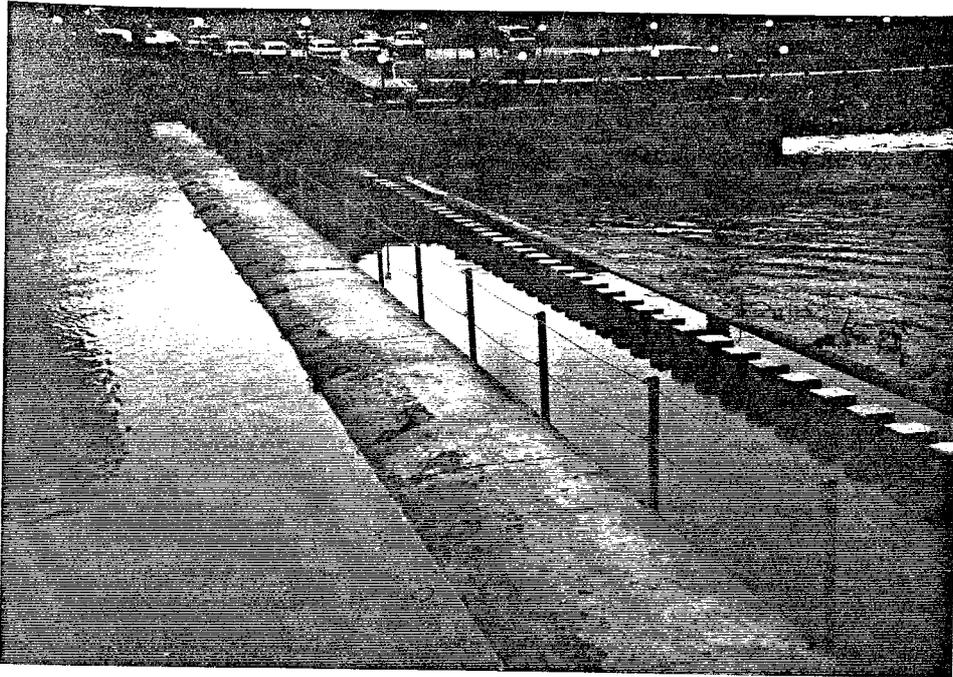
With the pool drawn down, the crest of the dam was observed (reference Photograph 26). Concrete was found to be sound over the entire length of the spillway. Expansion joint material/sealant is deteriorating and missing in some areas.

Photograph 26. Overflow spillway crest.

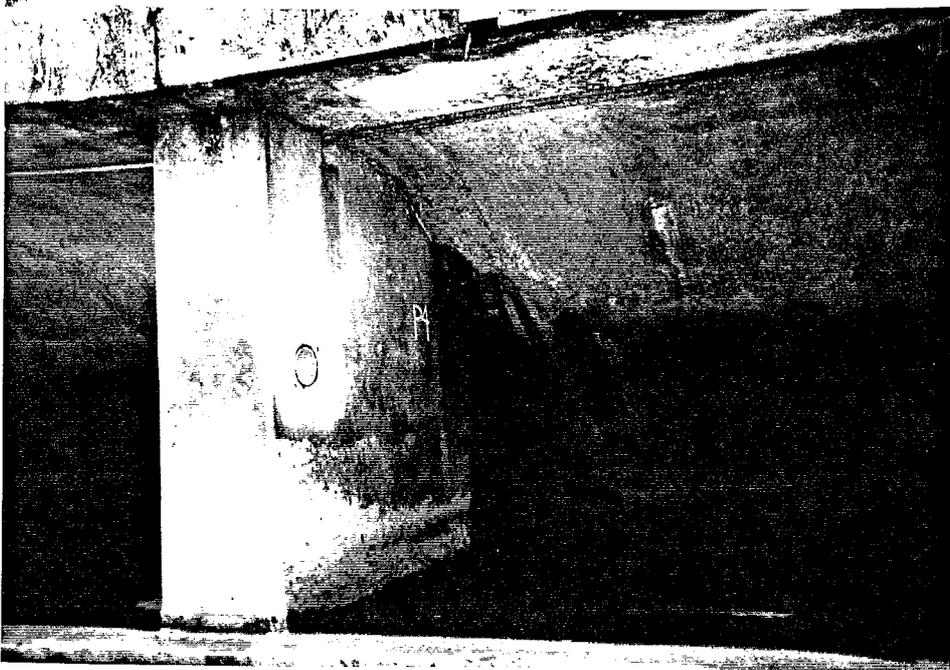
- Minor spalling is present at top of downstream edge of Pier 4 (reference Photographs 35 and 36).

- Water is leaking through the apron joint above Pier 4 and is visible on left side of Pier 4. Leakage in this bay was also reported in 1987 [1]. Some vegetation is present on the side of the pier.
- Unsound concrete is present near the top of the left side of Pier 8.
- A small amount of leakage is visible through the apron joint above Pier 8 and is visible on left side of Pier 8 (reference Photographs 45 and 46).
- A small amount of leakage is visible through the apron joint above Pier 9 and is visible on the left side of Pier 9 (reference Photograph 48).
- As shown on Photograph 50, several leaks are visible in the apron between Piers 10 and 11. Unsound concrete is also present in the leakage area. This problem was also reported in 1987 [1].

Photograph 36. Left face of Pier 4. Note leakage.

- f. The stilling basin voids should continue to be monitored.
- g. The deteriorated concrete on the overflow spillway should continue to be monitored but no repairs are presently recommended. Specific areas include Pier 4, Pier 8, Pier 9, and Bay 10.
