EVALUATION REPORT

RUM RIVER DAM

CITY OF ANOKA, MINNESOTA

October 1996

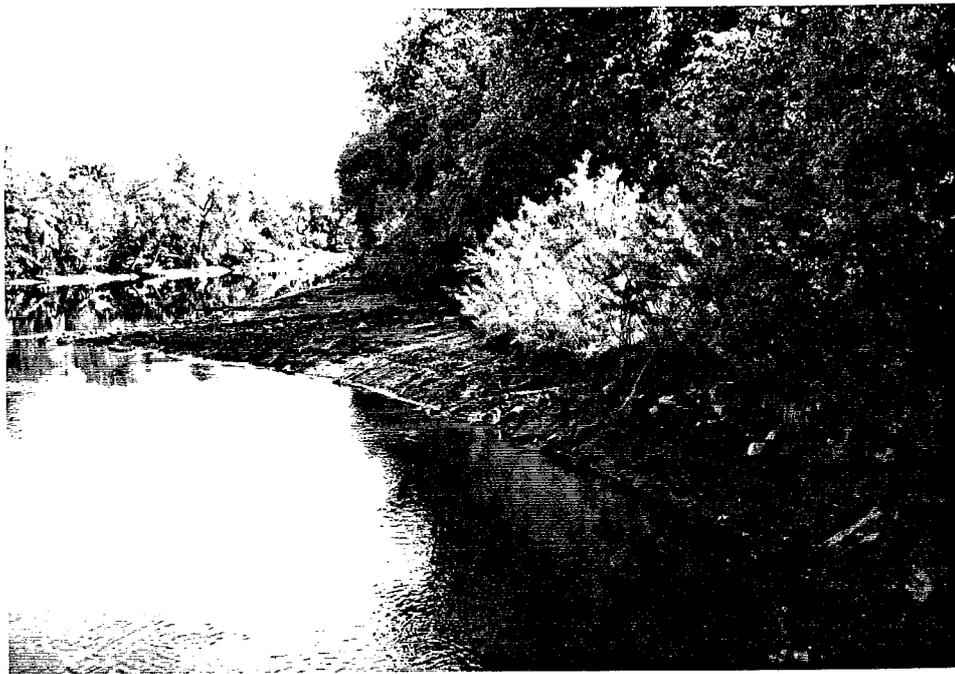
Photograph 2. Left bank of upstream pool.

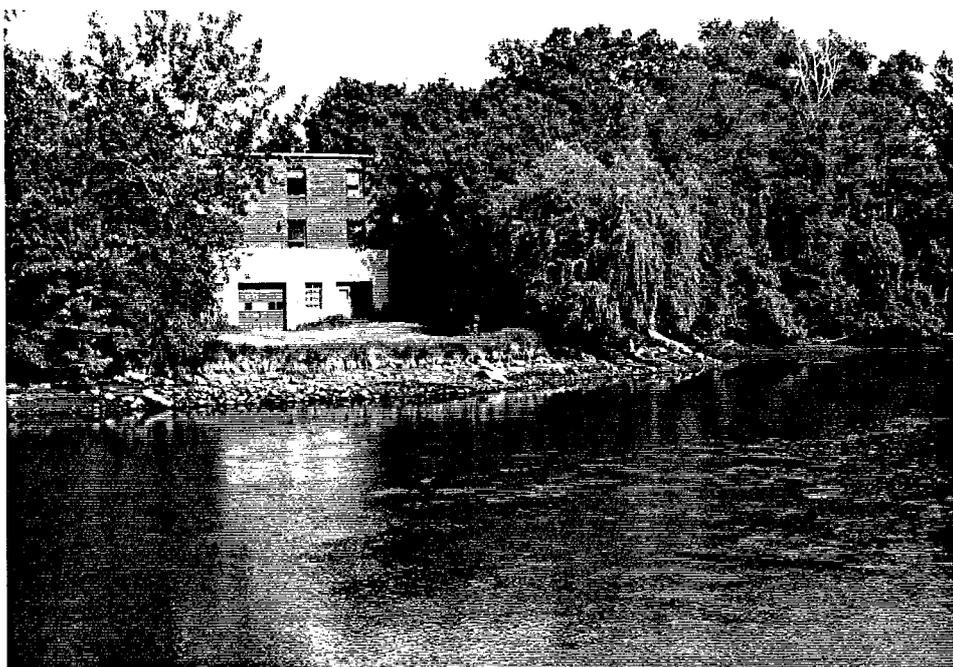
Photograph 3. Right bank of upstream pool.

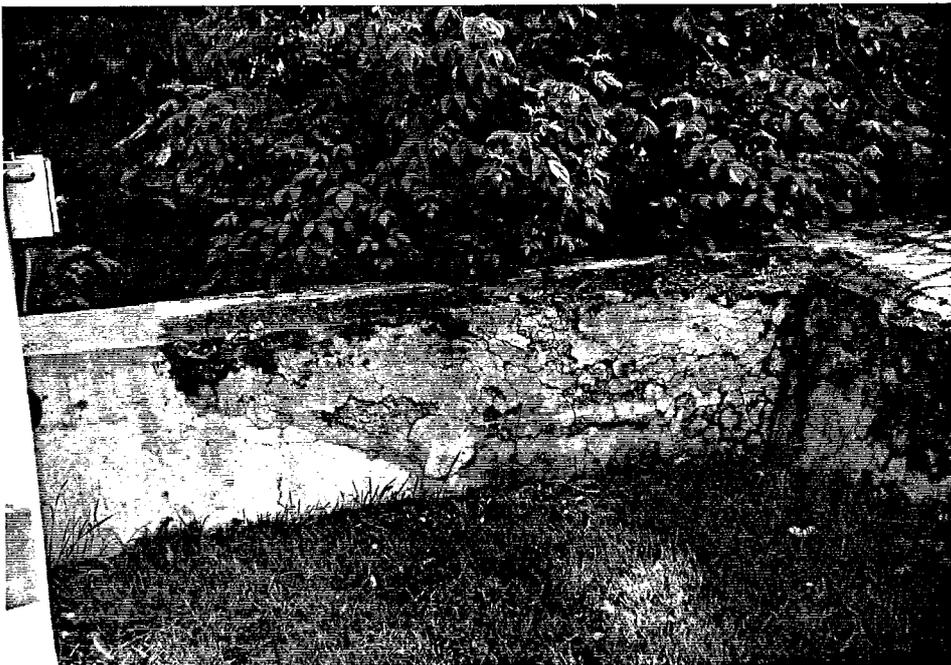
Photograph 5. Downstream view of "floodwall".

- f. A new paint system should be applied to the tainter gate. Reference Photograph 22.
- g. Repair the surface concrete of the floodwall in the left abutment area. Reference Photograph 5.

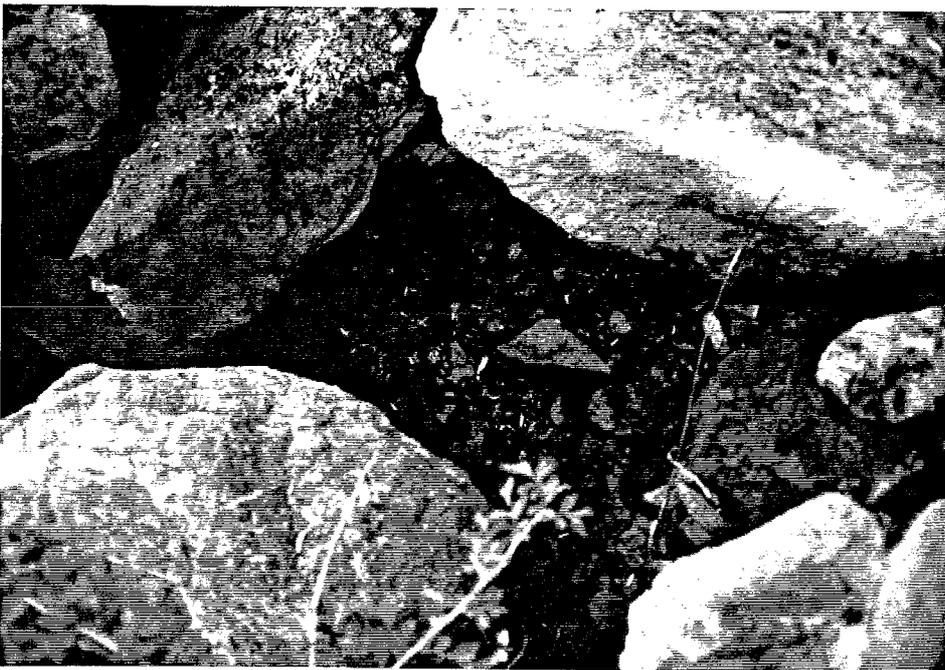
Photograph 15. Seepage along downstream left bank.

- j. The seep observed on the left bank, should continue to be monitored. Reference Photograph 15.
- k. The right downstream revetment should continue to be monitored for loss of riprap protection. Reference Photograph 12.

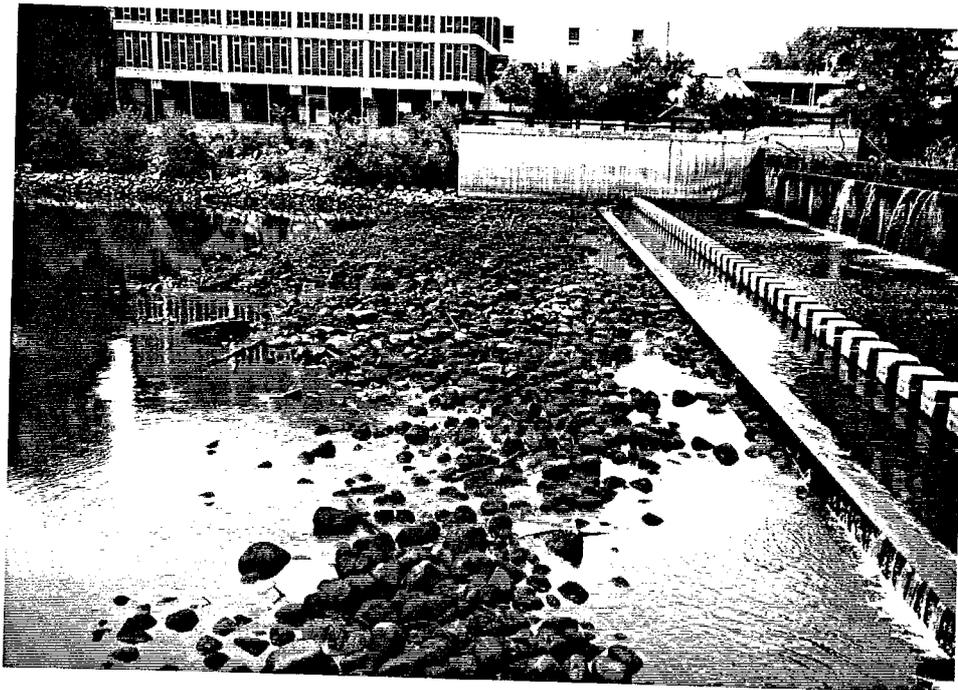
Photograph 27. Right portion of stilling basin (dewatered). Note absence of scour.

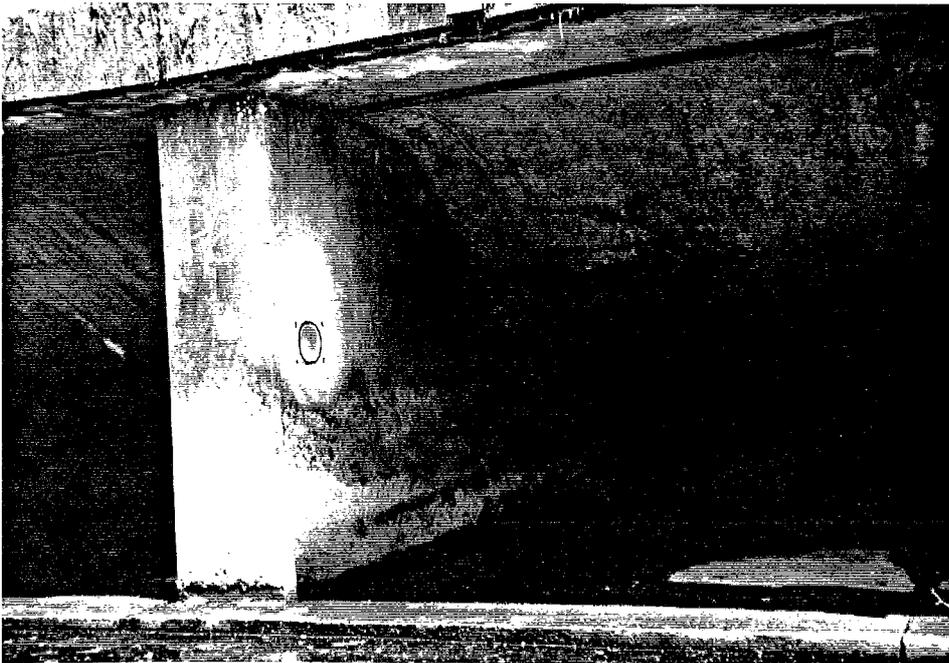
Photograph 41. Left face of Pier 6 & Bay 6 apron.

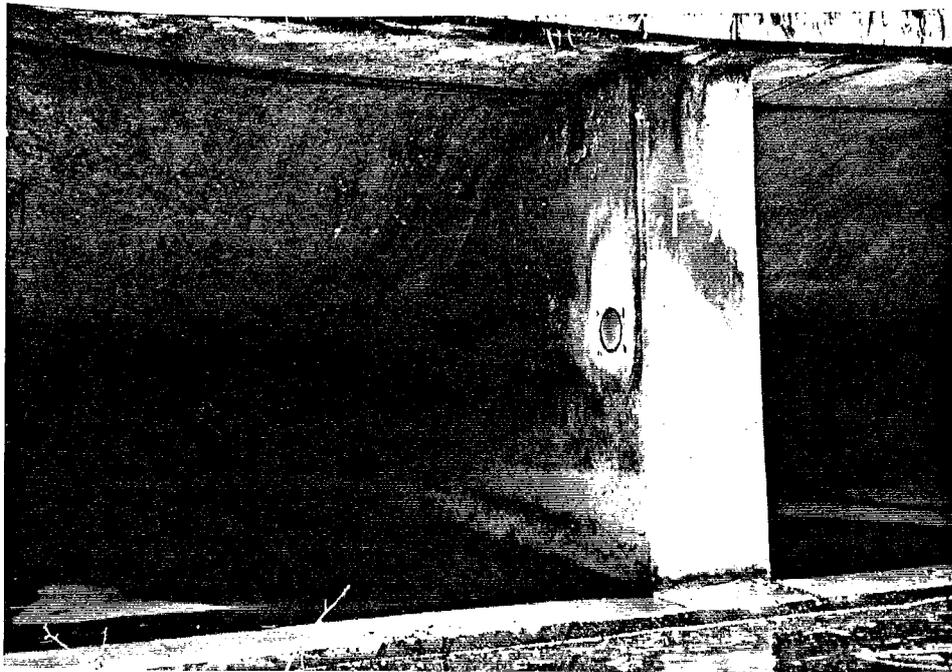
Photograph 42. Right face of Pier 7 & Bay 6 apron.

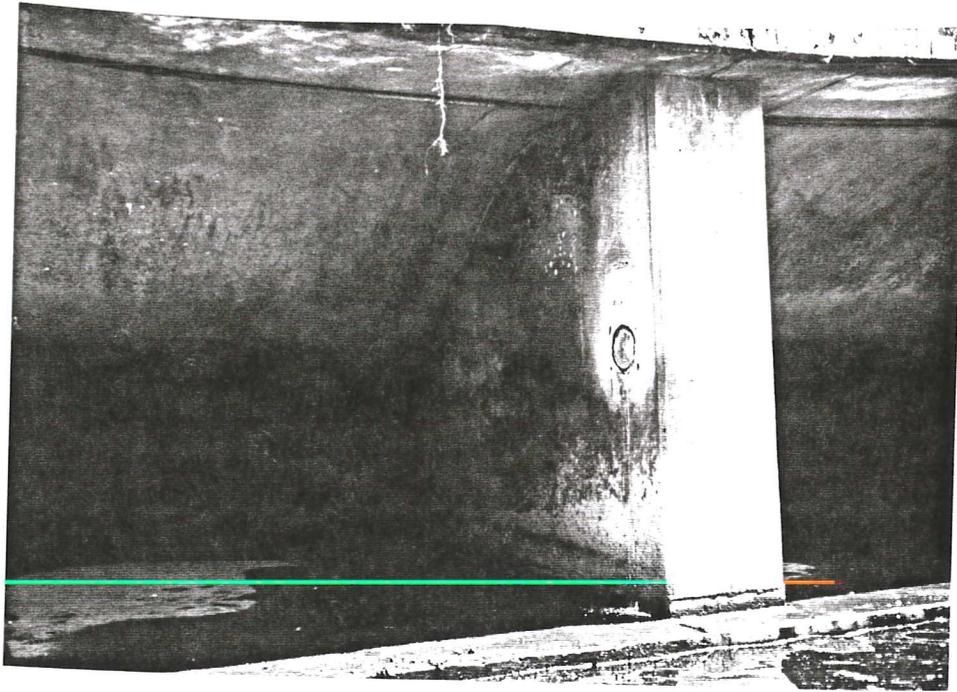
Photograph 44. Right face of Pier 8 & Bay 7 apron.
